From the Investigator L'enquêteur vous informe

Aircraft Occurrence Summary Résumé d'accident ou incident d'aéronef

TYPE: Glider Schweizer 2-33

DATE: 07 August 2006

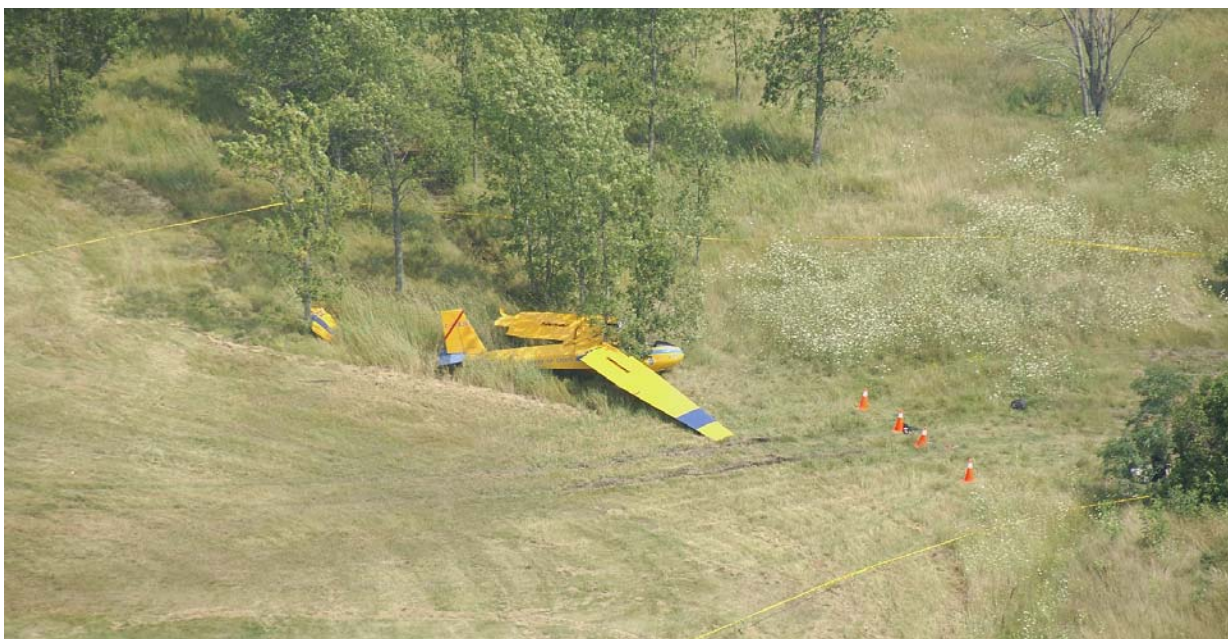
The glider contacted the ground in a short field, bounced, and impacted a stand of trees while still airborne. The impact caused severe structural damage, including ripping off the outer 10 feet of the left wing. The fuselage came to rest between two smaller trees. The glider received 'A' category damage.
